Sand Point Health Clinic 02.09-10.2006

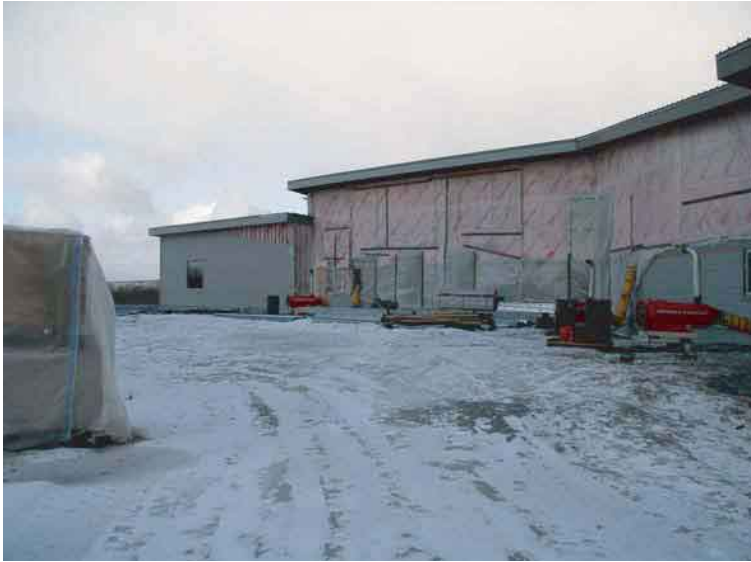
South facade, horizontal siding, temporary water-proofing over air barrier.

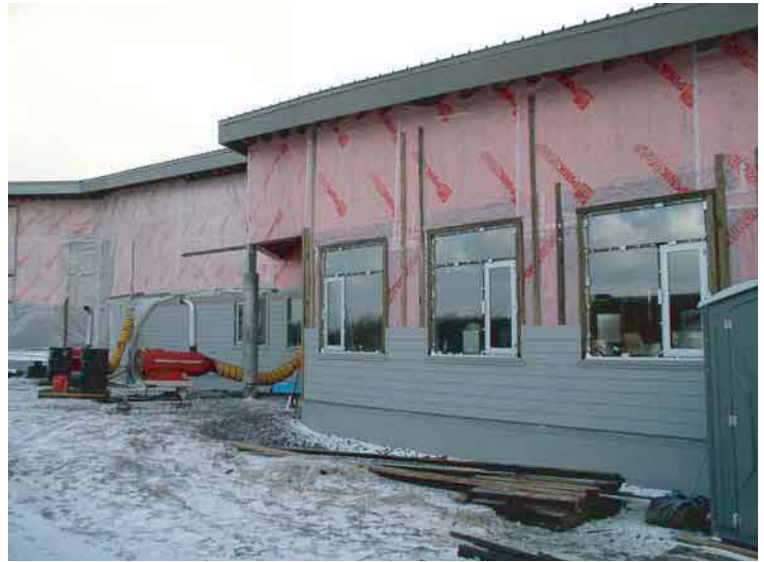
South facade, horizontal siding and temporary waterproofing over air barrier.

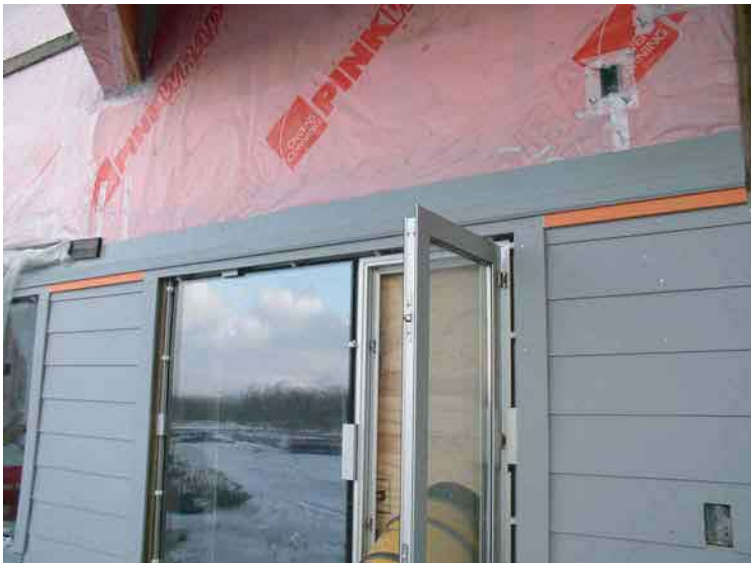
Transition trim between horizontal and vertical siding, south facade.

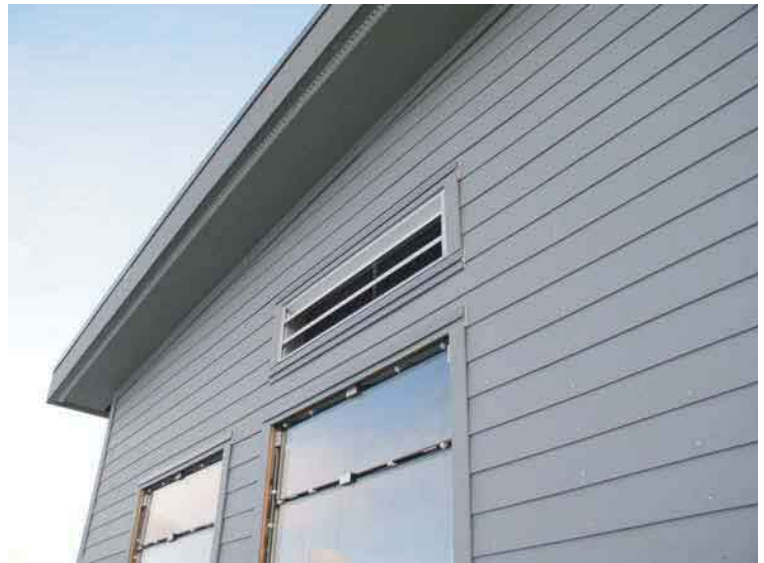
Completed siding, eave soffit and fascia, windows and exterior louver at dental wing.

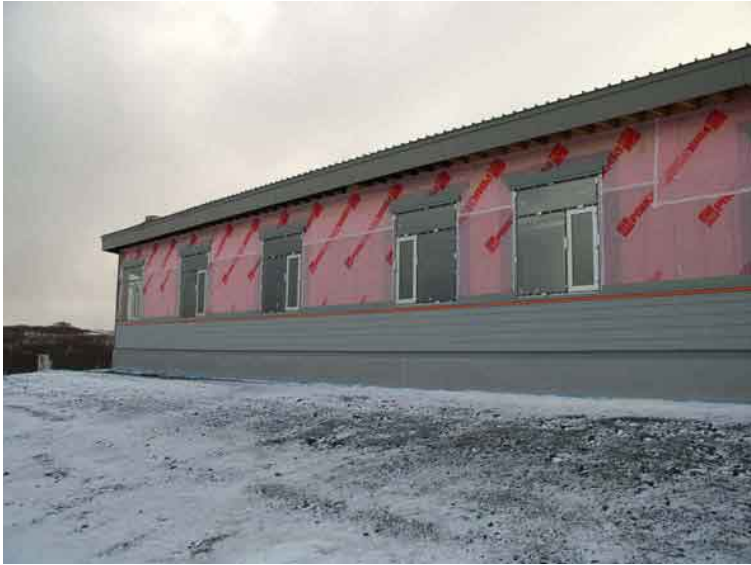
Extent of horizontal siding on northwest facade.

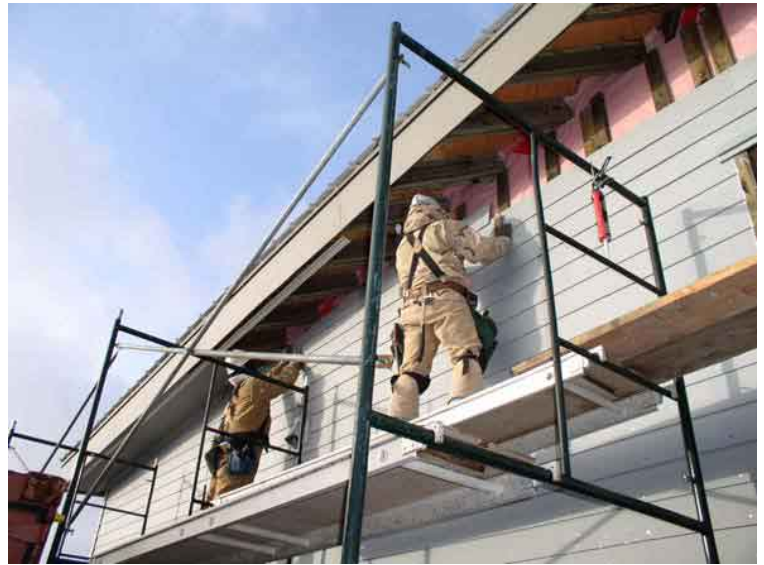
East facade siding in progress at the ambulance bay.

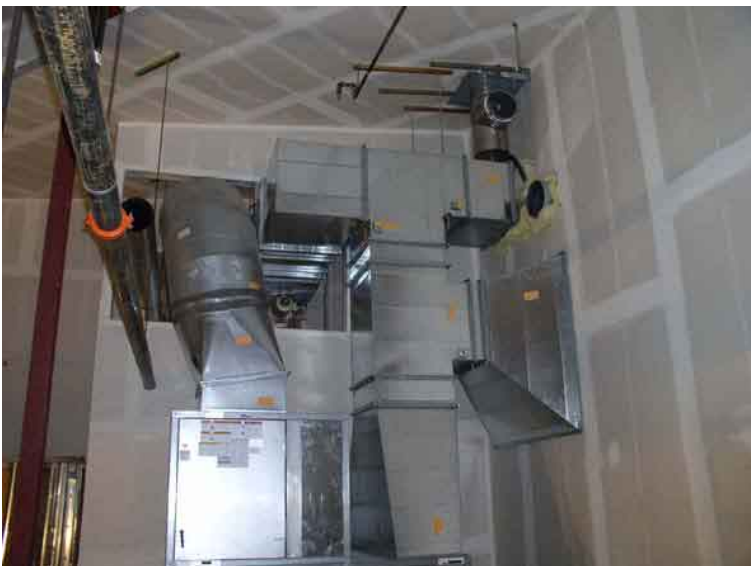
Installed air handling unit in the Mechanical Room

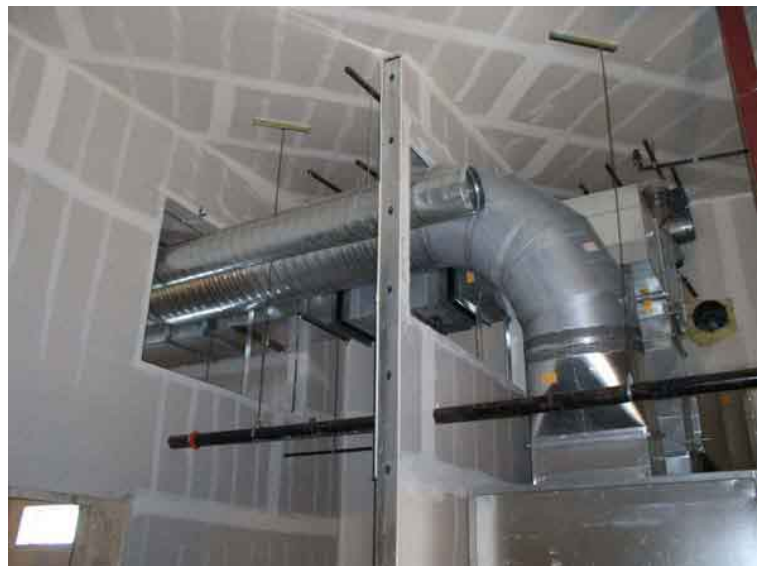
Main duct-runs out of the Mechanical room and through associated wall framing.

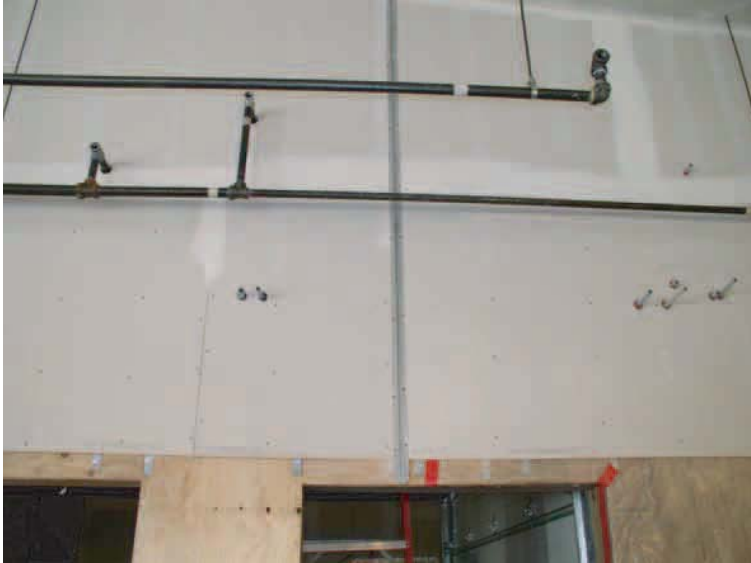
Vertical control joint in gypsum wallboard. Current extent of gypsum wallboard shown. Examples of installed sprinkler piping and electrical rough-in visible. South face of interior shear wall at Waste 145

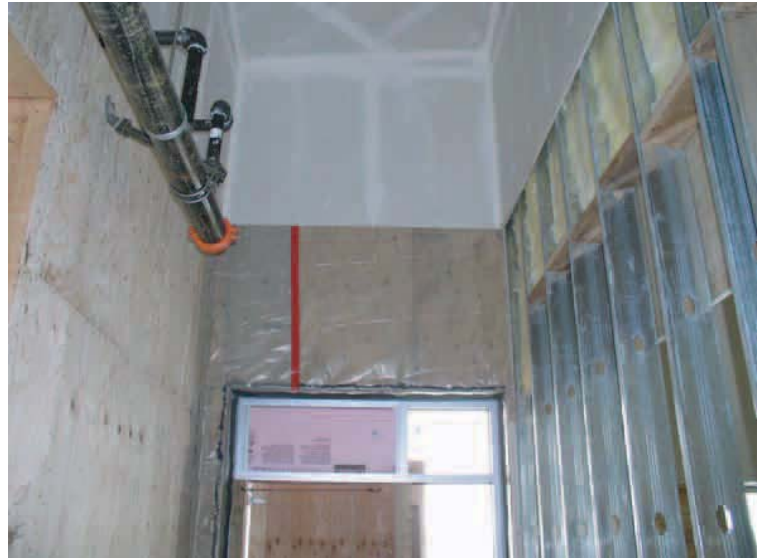
Secondary front entrance; sound insulation, acoustic sealant, vapor retarder, metal wall framing, gypsum wallboard, aluminum storefront and sprinkler main visible.

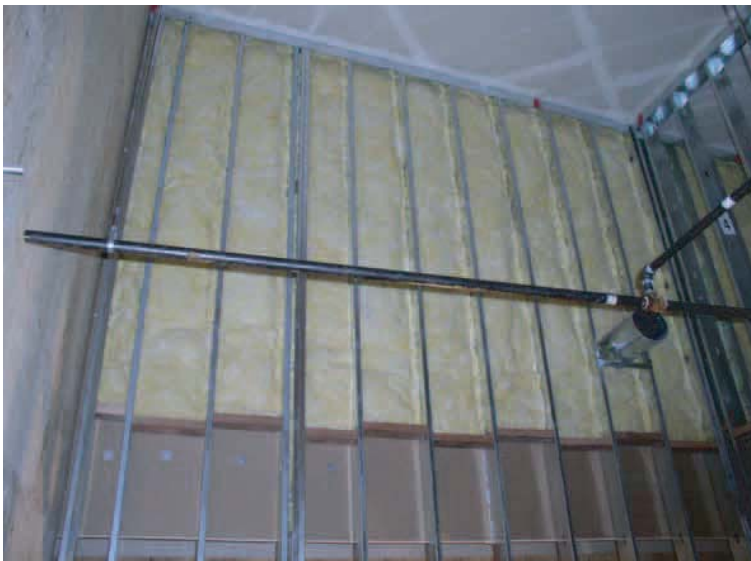
Metal framed full height interior partition wall with acoustical insulation, fire-blocking and current extent of gypsum wallboard shown.

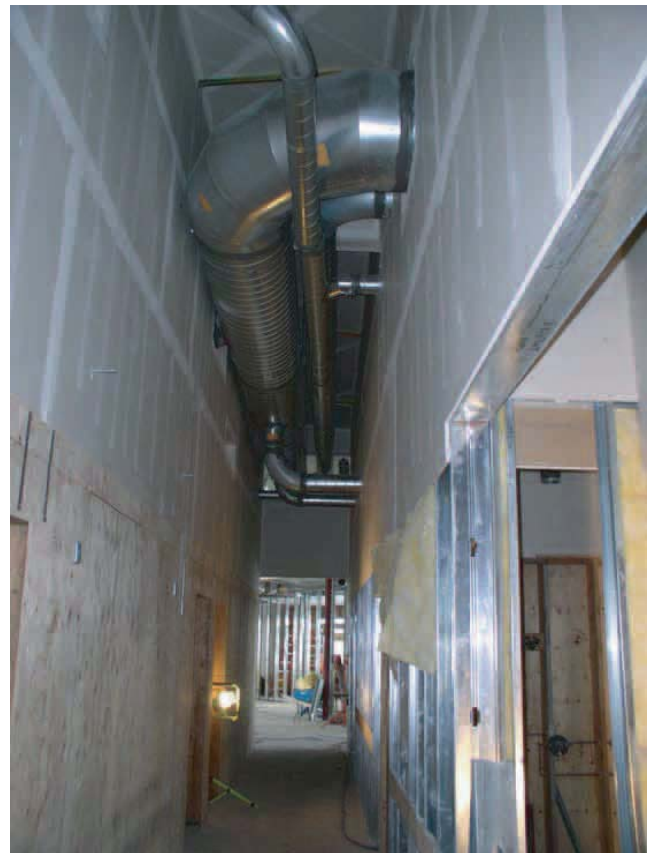
Looking east along main corridor, main ducting-runs, acoustical insulation and extent of gypsum wallboard visible.

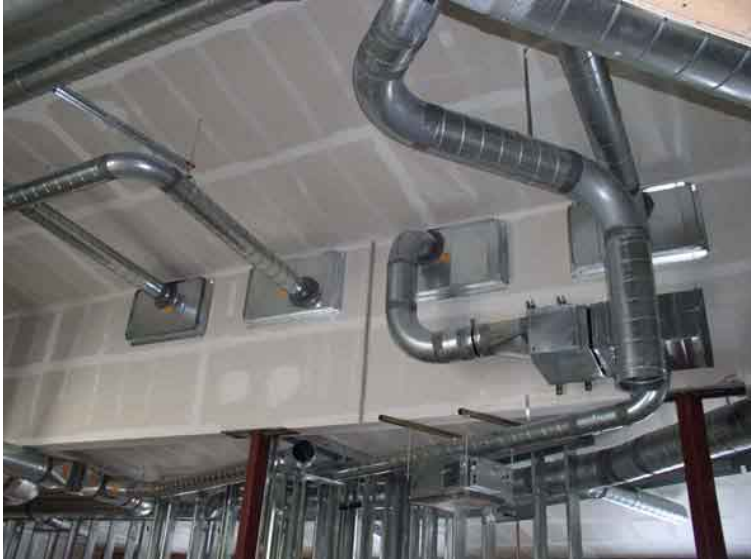
Mechanical ducting and interior of exhaust louvers along the clerestory wall above Lab 130.

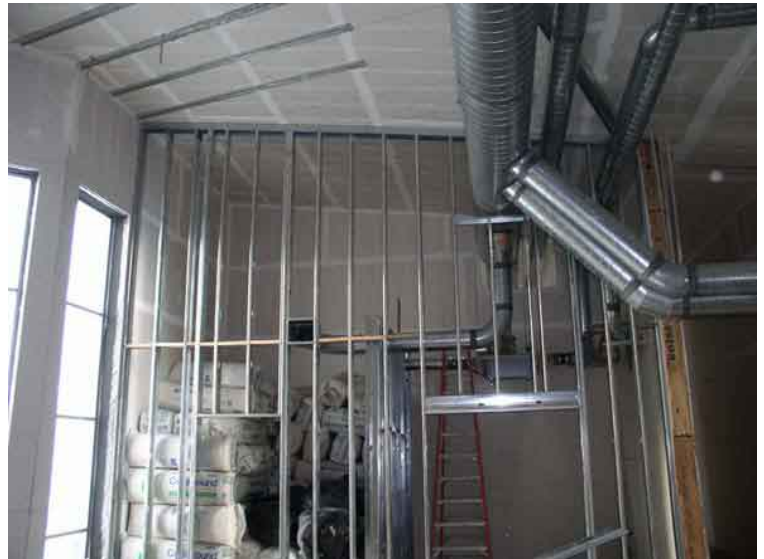
Metal framed full height partition wall at Exam 120. View looking west from the Nurse's Station.

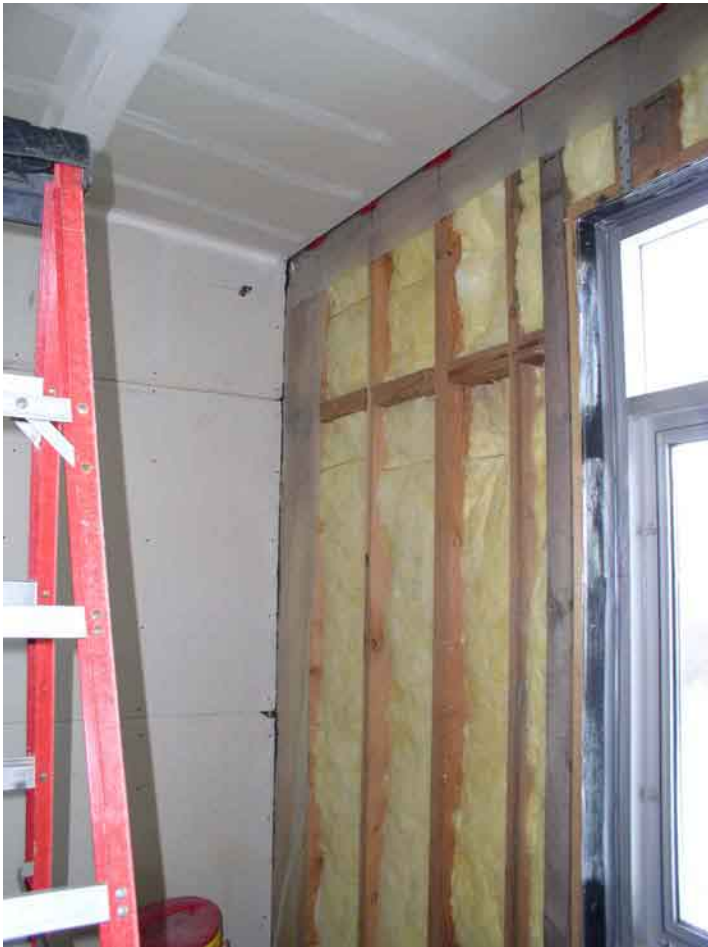
Exterior wall insulation, vapor retarder, gypsum wallboard, acoustical sealant and elastomeric membrane flashing.

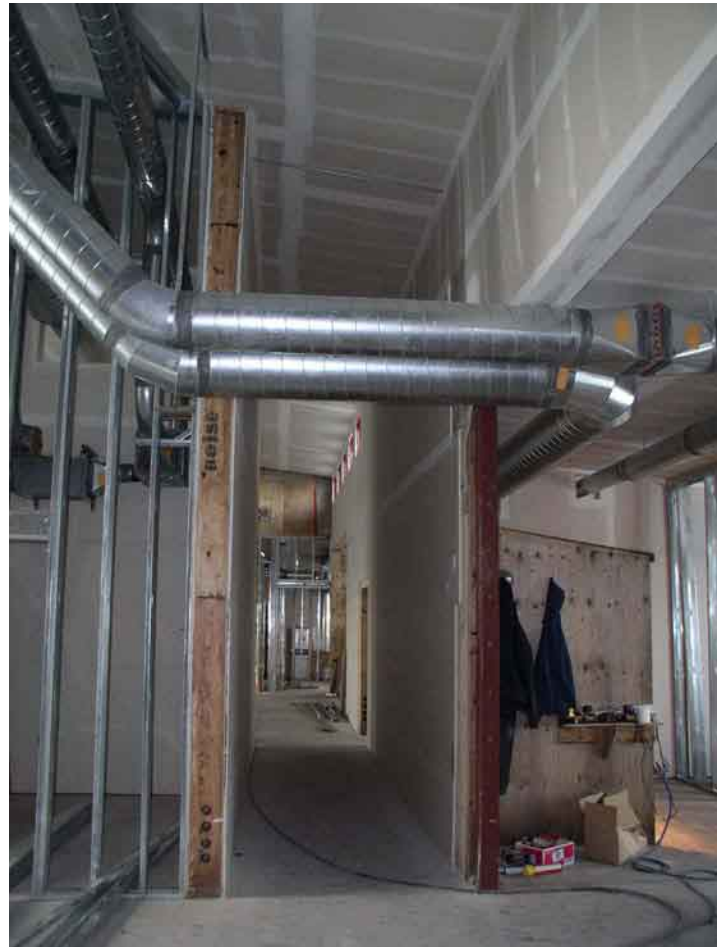
Main corridor looking west from the Nurses Station. Gypsum wallboard installed floor to ceiling along sections of the interior shear walls.

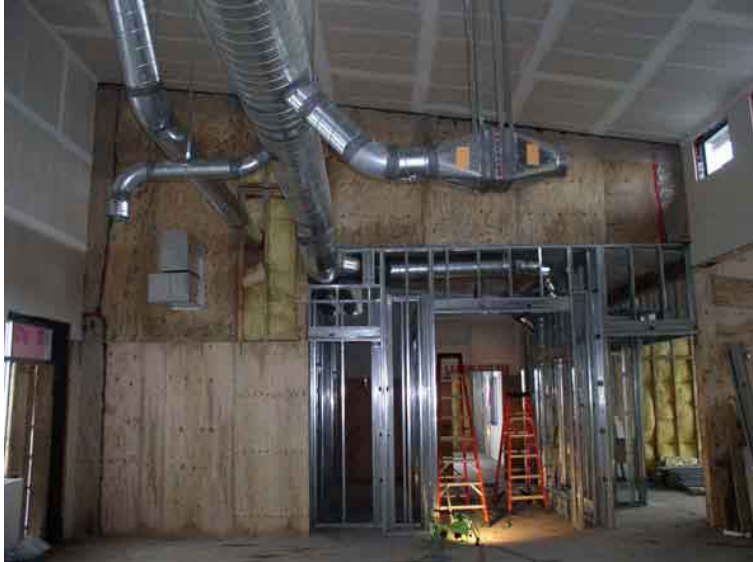
Mechanical ducting and equipment above the main entrance, looking towards the dental wing. Metal framed partition walls of the conference room and public restrooms beyond.

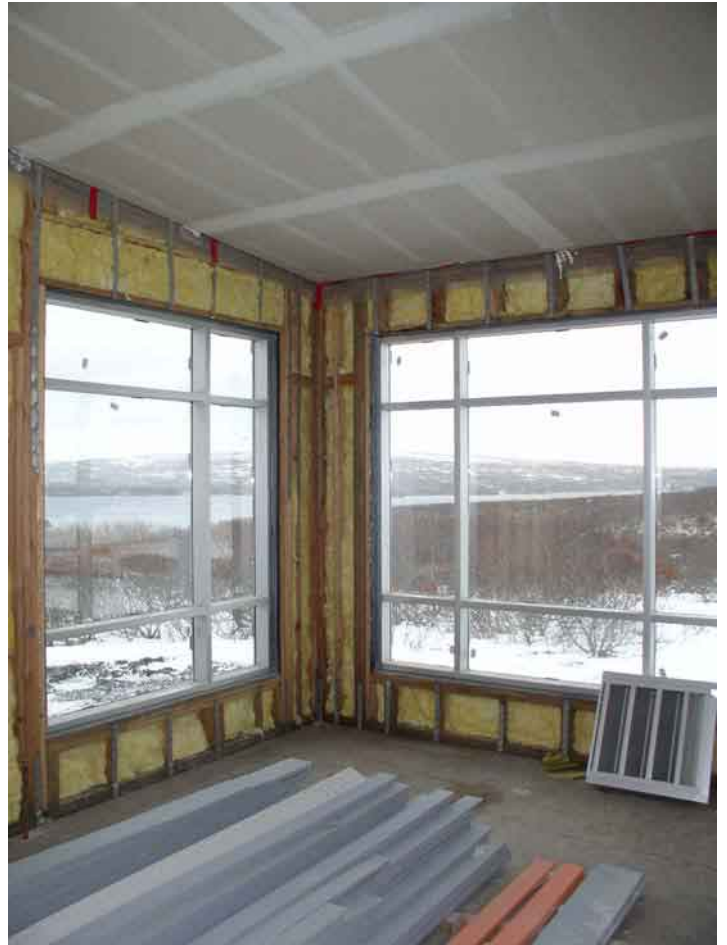
Northwest corner of the main conference room. Cement fiberboard trim pieces in foreground.

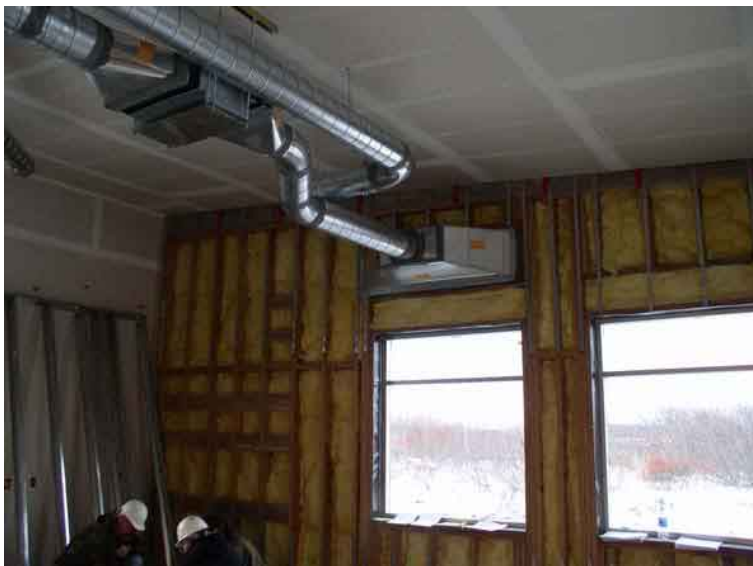
Interior of Dental wing showing extent of gypsum wallboard, insulation, mechanical ducting and exhaust louver.

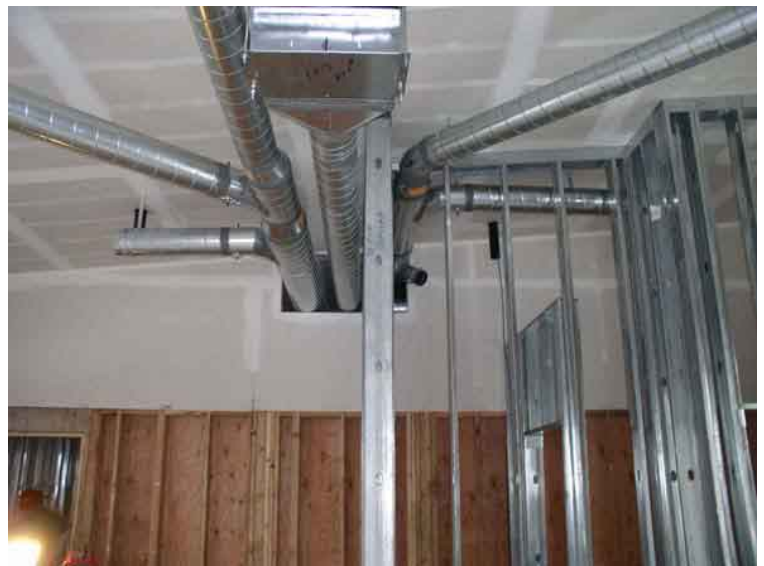
Interior wall of the Dental wing showing extent of gypsum wallboard and metal framed partition walls. Example of excellent ductwork coordination and installation.
